GUAM ENVIRONMENTAL PROTECTION AGENCY • *AHENSIAŇ PRUTEKSIÓN LINA'LA' GUÅHAN*

July 23, 2021

SUBJECT: Site Inspections at Samsung Mangilao Solar Project Site, July 23 and 18, 2021

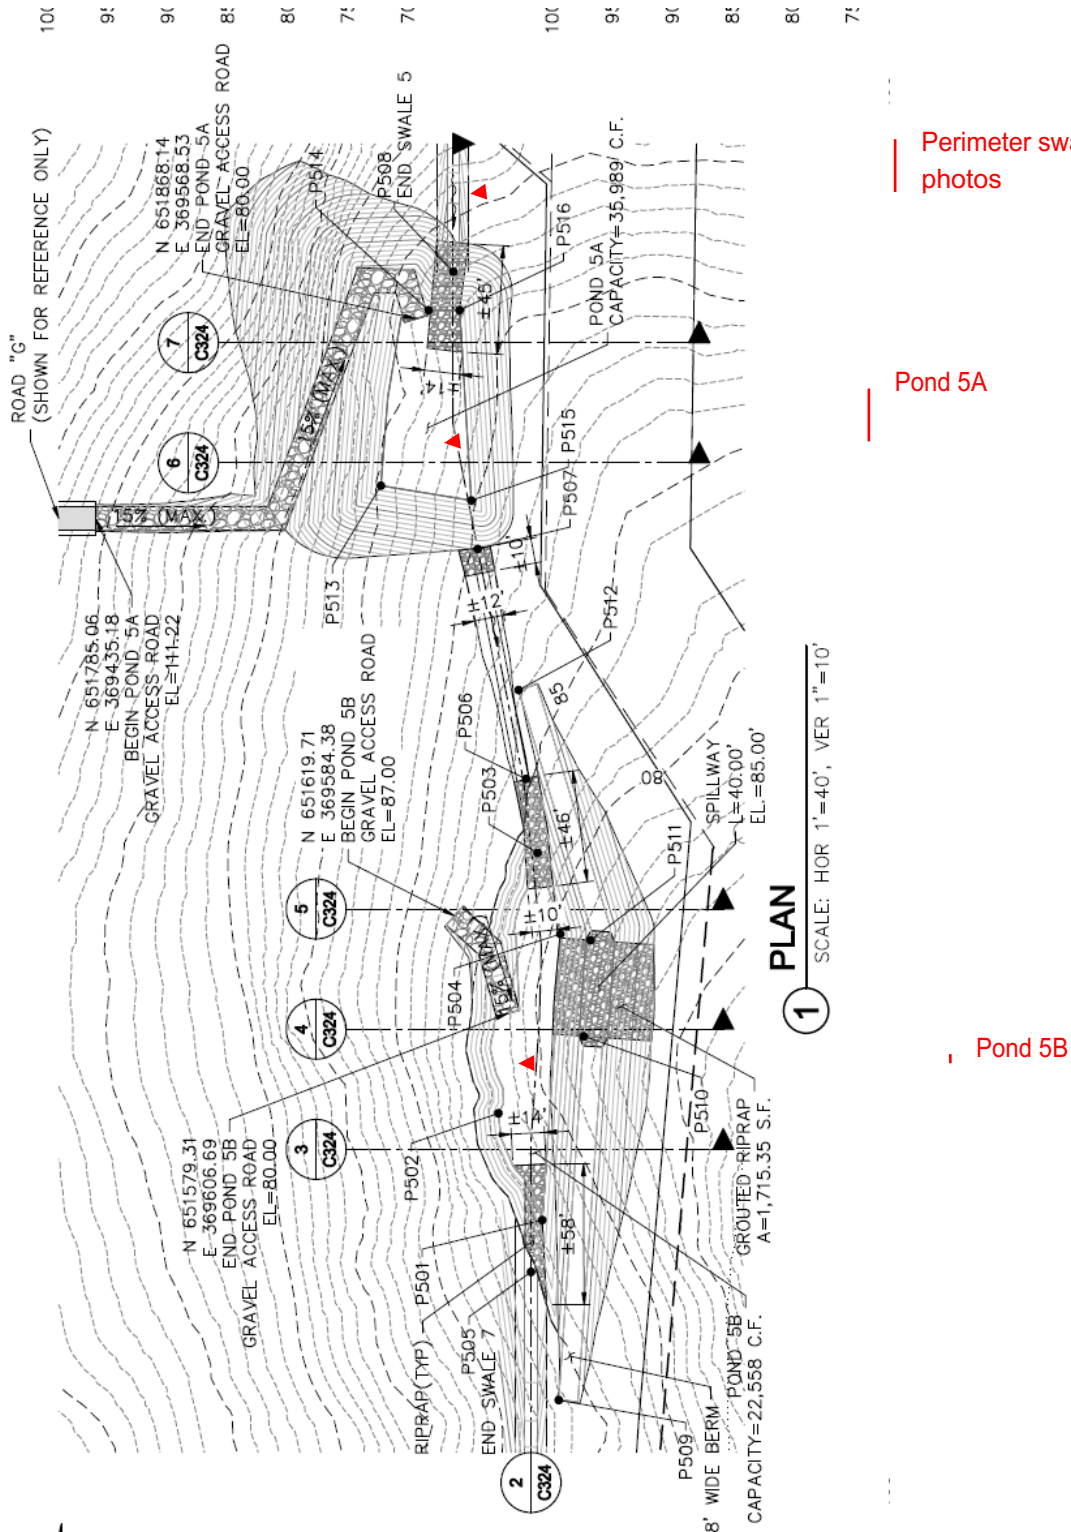
Upon review of revisions to the E&SC plan approved by GEPA on January 4, 2021, which added Pond 5, I conducted a second inspection at the site to further investigate the area that we had observed which appeared to have discharged off-site toward Marbo Cave.

ADDENDUM: Inspection of Pond 5, July 28, 2021. Excerpt from revised E&SC plans approved by GEPA January 4, 2021, adding Pond 5 to the area which would discharge toward Marbo Cave:
